Laboratory Test Report

Product Name: Sealux Waterproofing Strip Membrane (EAU2000112)

Project No.: 2104T0030.01

Test Methods: ASTM D7281

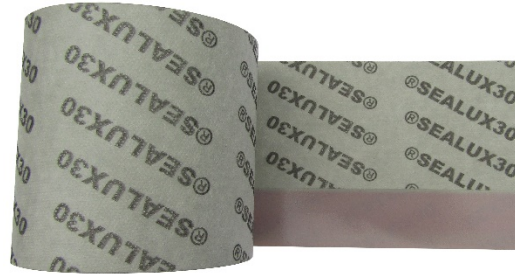
Results Summary: Pass - No Visual Presence of Water After Cycling

Sample Description: Two (2) 3" x 6" samples were excised from the shower tray; lengths of EAU2000112 membrane were then adhered to the shower tray samples with a 1" overlap bonding the smooth area of the membrane to the shower pan with C920 compliant silicone.
